CAUSAL INVESTIGATION REPORT

UNPLANNED INITIATION OF EXPLOSIVES AT PEAK GOLD MINE

18 May 2022

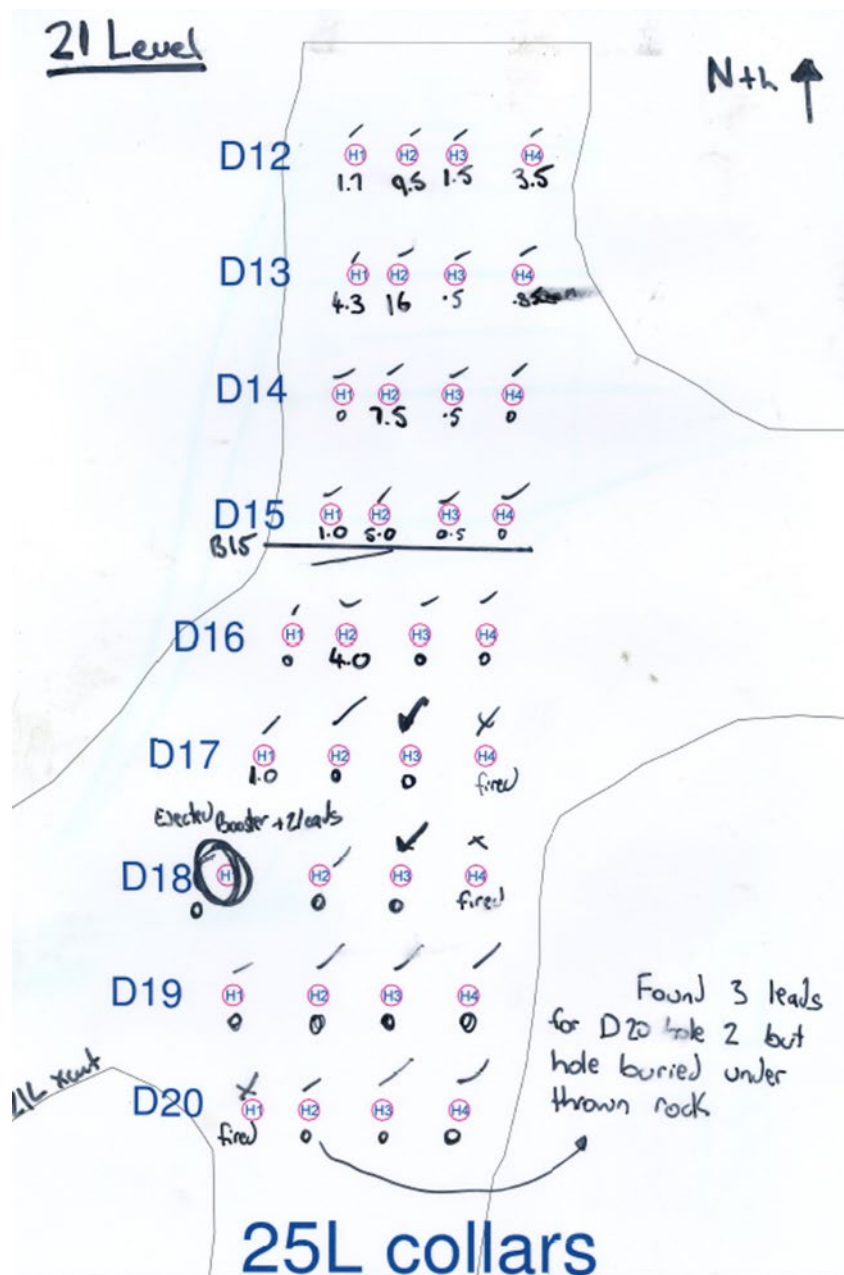
to the mains firing line. On closer inspection he saw sections of the charged shot in the stope had heaved, indicating detonation had occurred.

Figure 1: Post incident – charge plan showing location of the fired holes resulting from the unplanned initiation

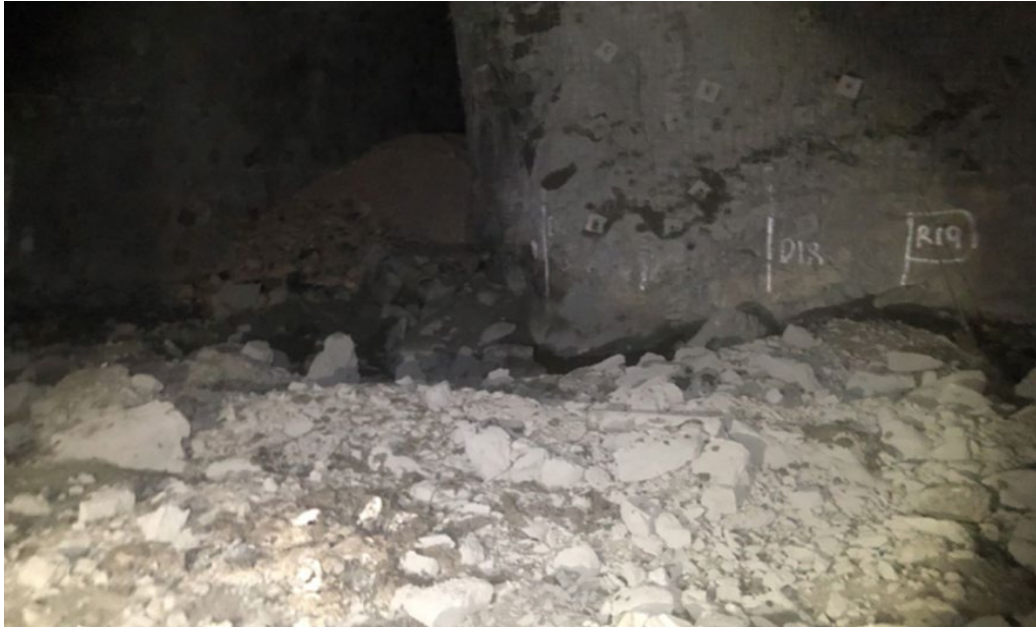
Figure 2: Post incident - Photo of 21L showing floor heave in line with mark-up of the charge holes (painted on wall)

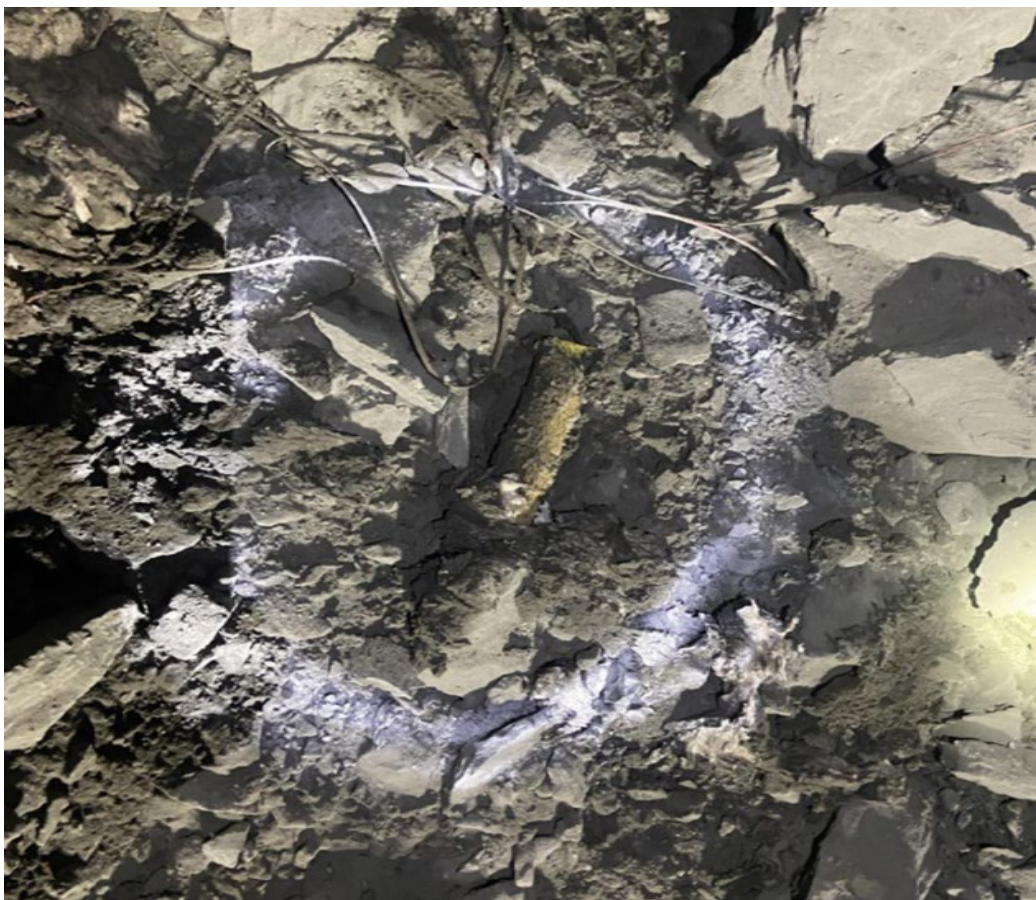
The immediate cause of the incident was the application of a 240v AC pulse to the I-Kon III detonators resulting in detonating explosive product.

Figure 3: Post incident – Detonator ejected from D18H1 during event (in-situ)

1. Physical removal the 240v AC mains firing system from all firing points.
2. Remove all electric detonators from service.
3. Replace electric detonator use across site with I-Kon electronic blasting system for all blasting activities (development and production).
